## **Marsden Park Developments Pty Ltd**

### **Preliminary Report for Marsden Park Industrial Precinct Geotechnical Assessment**

May 2009

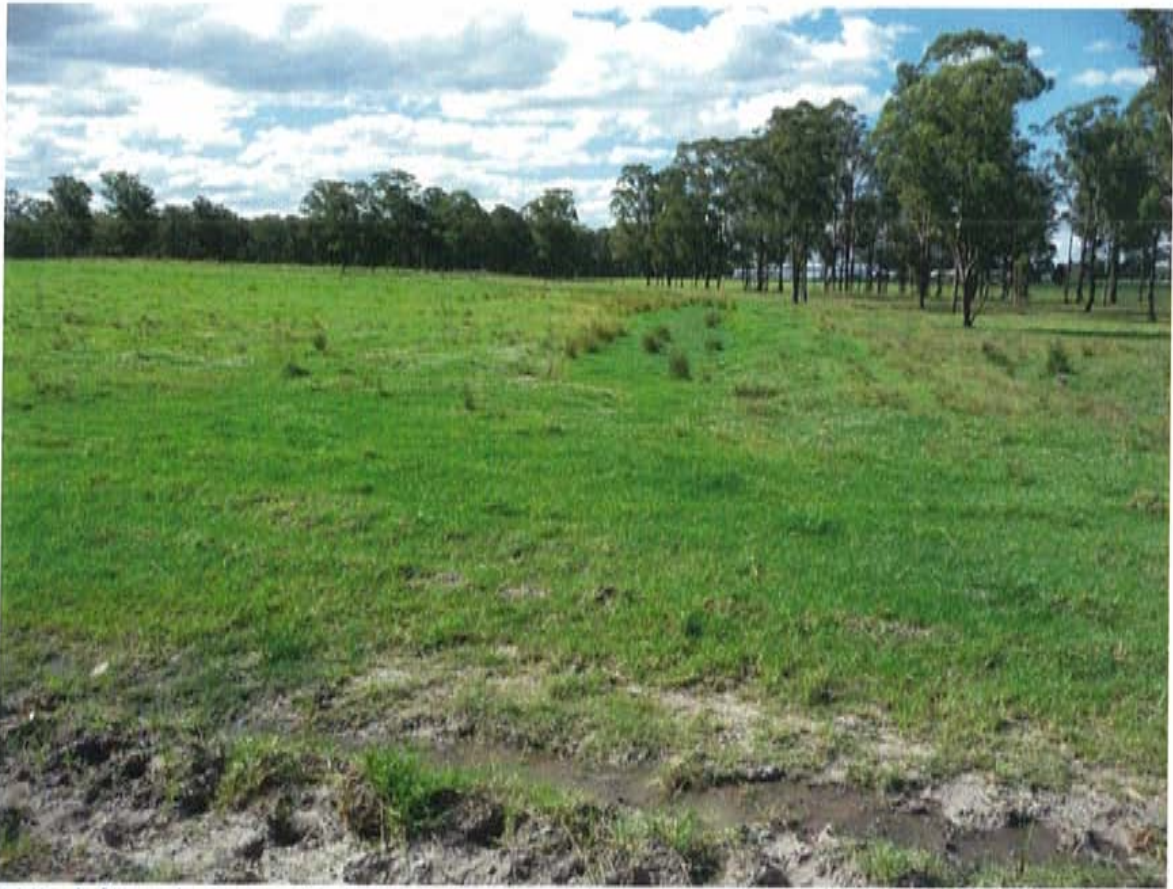
- ▶ Surface and ponded water was observed in the higher landscape to the east of the quarry. This is inferred due to quarry/landfill operations. Refer P1, P2.

P 1 Head of Lower landscape valley in Upper landscape east of Quarry. View north from access road. Overland water flow and swale appear associated with quarry irrigation operations. East of Geotechnical Domain GD5

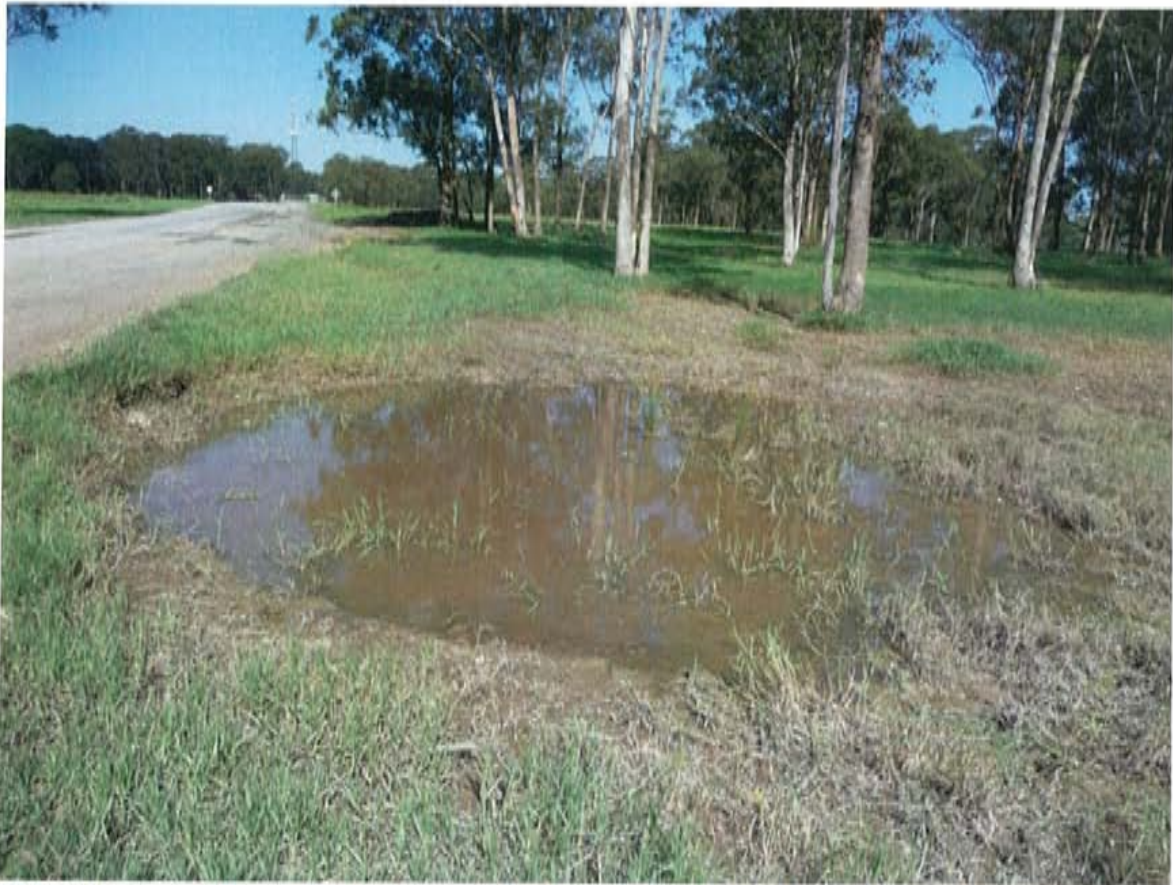
P 2 Access road east of Quarry. View east. Overland flow water emerging to pond south of the quarry access road.

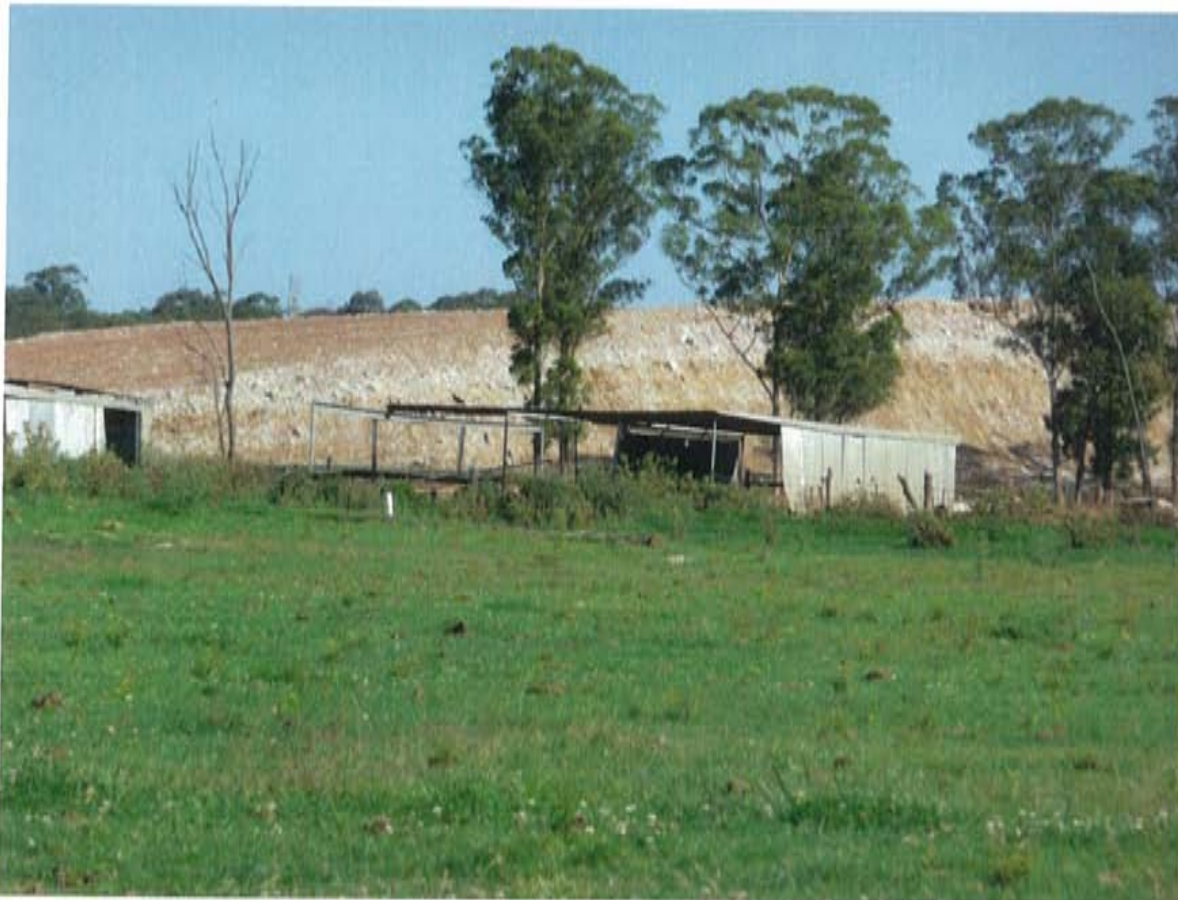
P 3 Stockpile of excavated material (predominantly clay) on NW corner of the quarry/landfill (GD5).

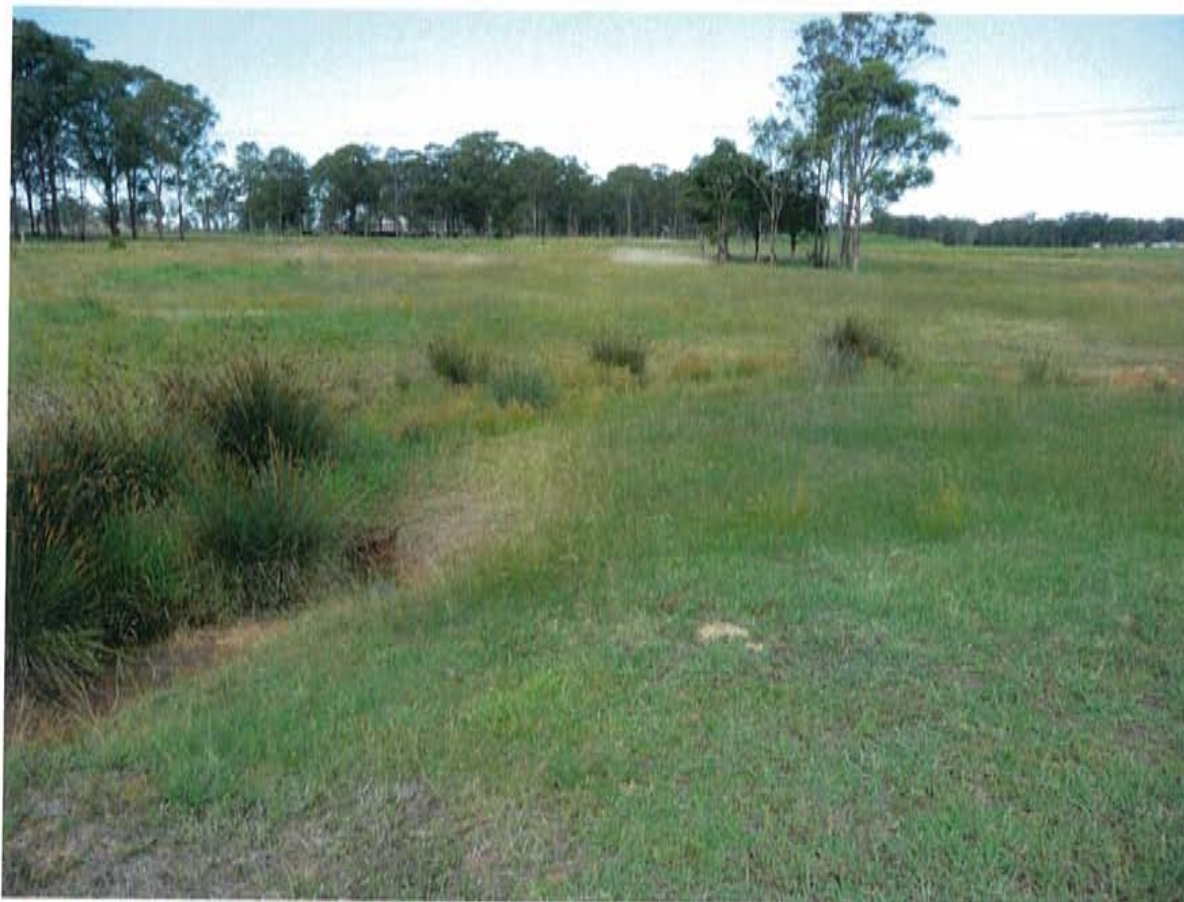
- ▶ Areas of localised filling were reported in the Phase 2 Contamination report, as well as filling greater than 2.5m thick in the SWF. P4 provides a view over the SWF from the west.

P4 Dispersive erosion on creek line, Fill area (GD5a) in background.

Development of this area will need to take account of the presence of this fill, which does not appear to have been 'controlled'. The condition of this fill will need to be geotechnically assessed for the evaluation of geotechnical treatment/management options prior to development. Treatment, subject to any contamination status constraints, could include but is not limited to excavation, stripping of the old topsoil/organic layers and replacement as engineered fill (under controlled moisture conditioning and compaction) for at least part of this area, or excavation and beneficial re-use within the landfill as a cover material.

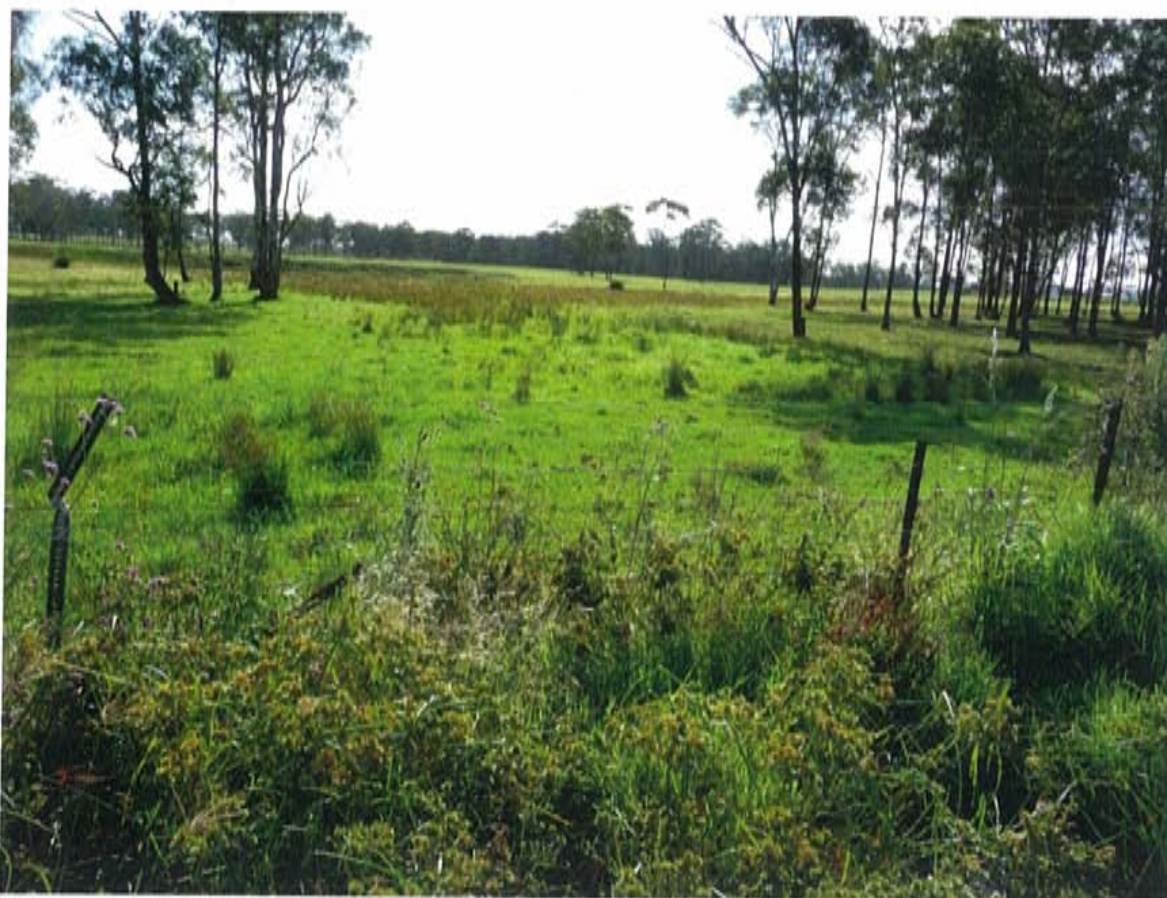
- ▶ Wetter zones were noted downstream of a number of dams. Such zones are typically the result of seepage/elevated groundwater within the lower landscape, which is elevated by the presence of the dam. Refer P5. Typically in dispersive clay environments, such as indicated for much of the site area, such seepage can lead to dispersive erosion (piping) failure.

P 5 Lower landscape east of Quarry and west of Richmond Road. Waterlogged ground below dam

It is noted that there are a number of existing small (farm) dams in the lower slope areas and to a lesser in the upper slopes. It is considered unlikely that these existing dams will meet current engineering design requirements, particularly with respect to protection measures against dispersive soil (piping) failure, and thus they may require removal for urban development purposes.

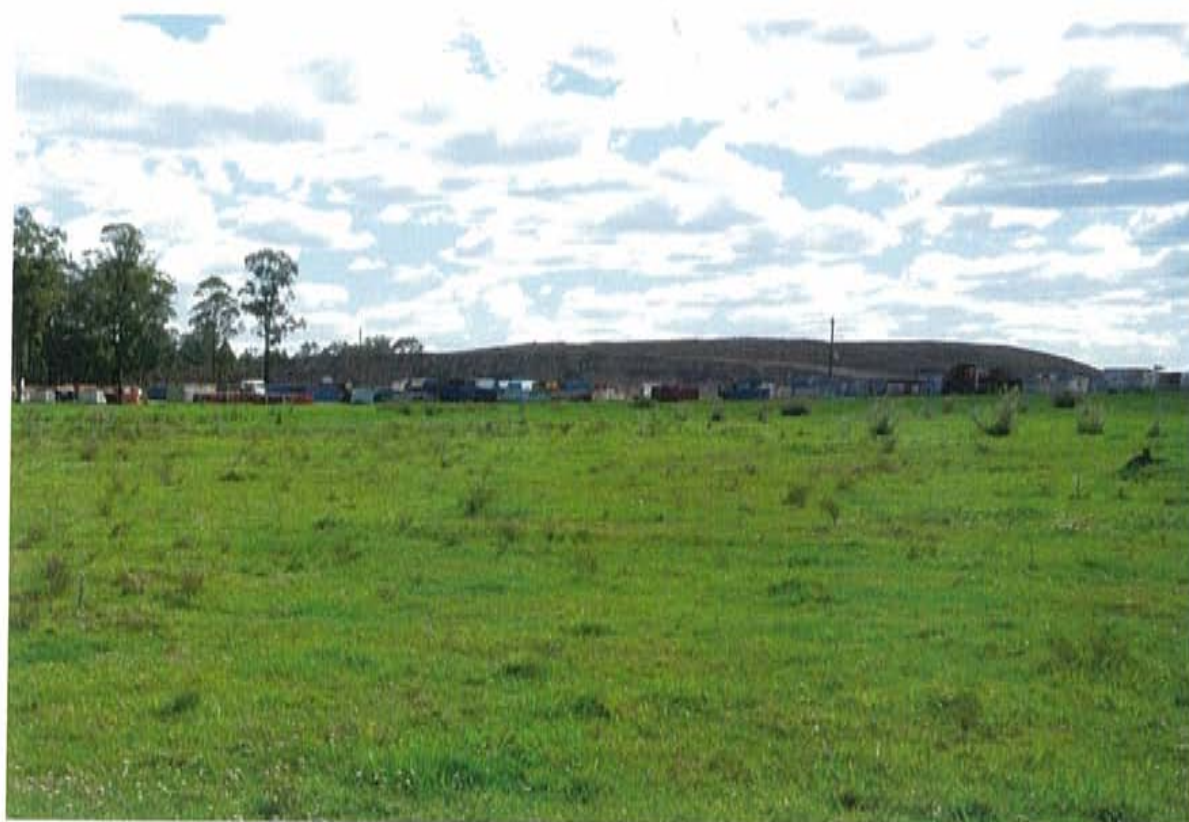
P6 Stockpiles of excavated material (mainly mix of clay and shale) east of the quarry/landfill area (GD5).
